FINDINGS

Beach Road Landslide

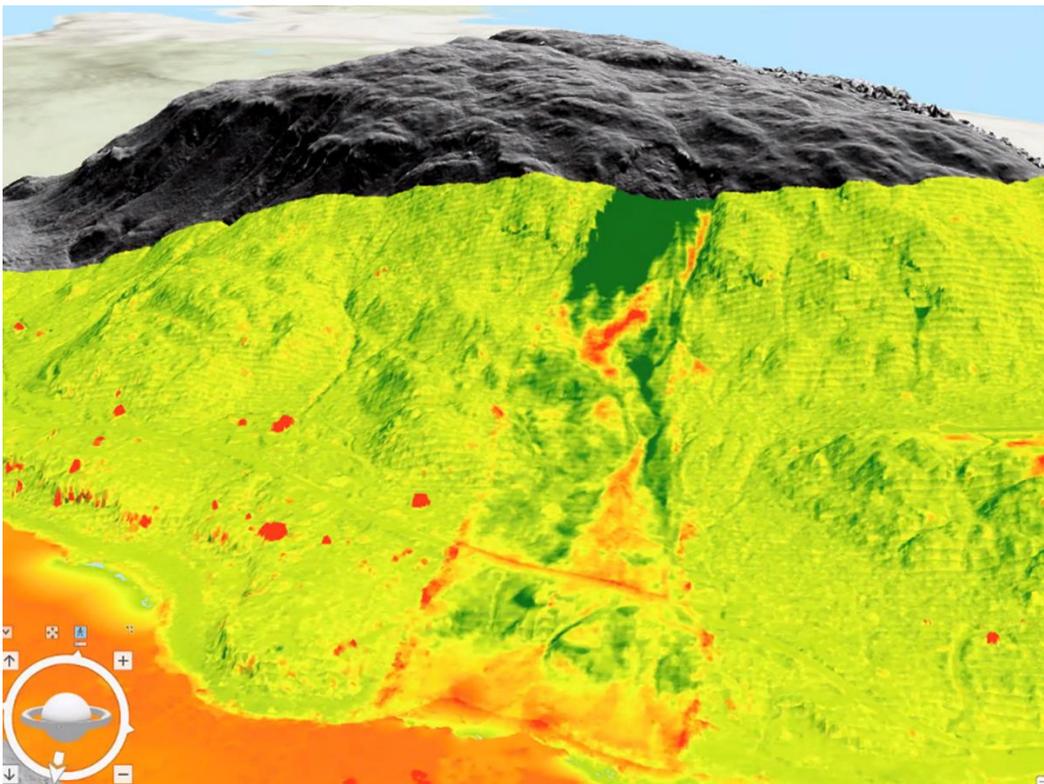
The Beach Road landslide measured approximately 500 ft wide and 2,500 ft long (measured from head scarp to shoreline), with additional deposition in the water. The release was likely triggered by a combination of bedrock failure and oversaturated soils that allowed the entire soil mass to become liquified and move downhill. The failed material was primarily bedrock in the upper portion of the slide, which then incorporated saturated soils and other surface materials as it traveled downslope in a debris flow. Based on lidar differencing (comparing lidar elevation data from 2014 with the newly-acquired 2020 data) there is a lot of material accumulated in the upper part of the landslide path that is likely rock debris that did not mobilize to the bottom of the slide. Very little scouring of the original land surface was observed in the lower part of the landslide path, suggesting a highly saturated debris flow.

Figure 2. Preliminary lidar differencing product showing areas of erosion in green and deposition in orange. The 2014 lidar does not extend to the top of the ridge so change analysis could not be done for the headscarp area.

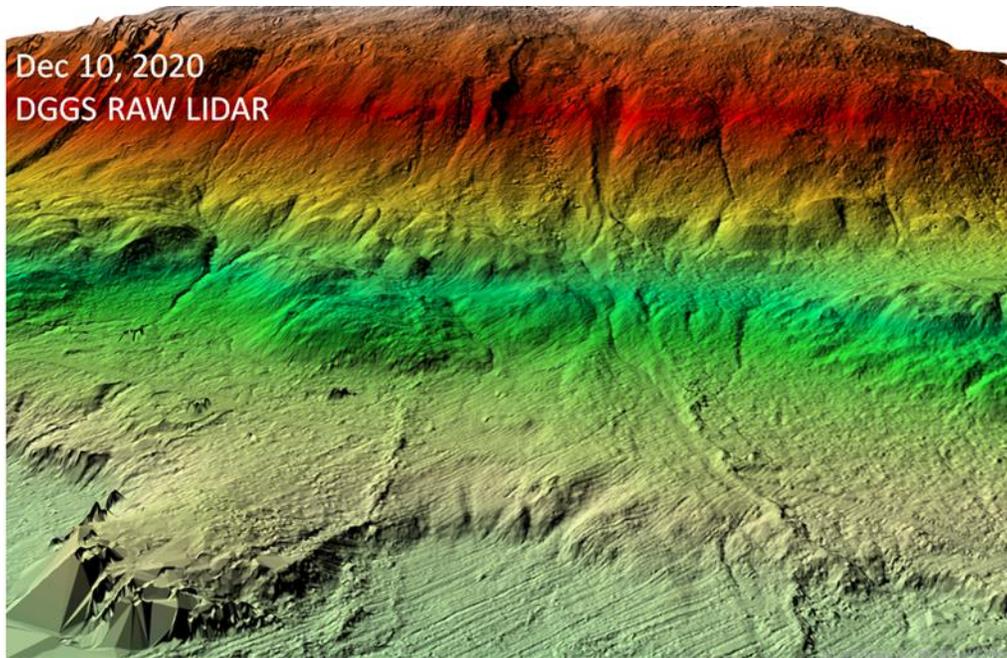
Our aerial observations and lidar data collected during December 5–10 revealed that there is an open fracture that continues south from the head scarp and is possibly part of the same fracture set that initiated the main landslide. We estimate its length to be about 160 ft. This fracture, and the potential consequences should it fail and trigger a landslide, remain a concern to our team because there are properties located in the potential runout zone. We consider freeze/thaw activity, heavy rain, snow load, seismicity, high winds shaking trees, and other factors as potentially capable of triggering a new slide with no advance warning. Landslide simulations of potential failure of the fractured rock mass associated with the large crack at the head of the Beach Road slide helped refine the Beach Road area of concern (AOC), but DGGG does not have the data or expertise to evaluate the stability of the fractured rock mass. We recommend a focused assessment by geotechnical experts to fully evaluate the stability of the rock mass and understand the risk going forward.

Figure 3. December 10 raw lidar elevation product showing Beach Road slide. View is looking west.

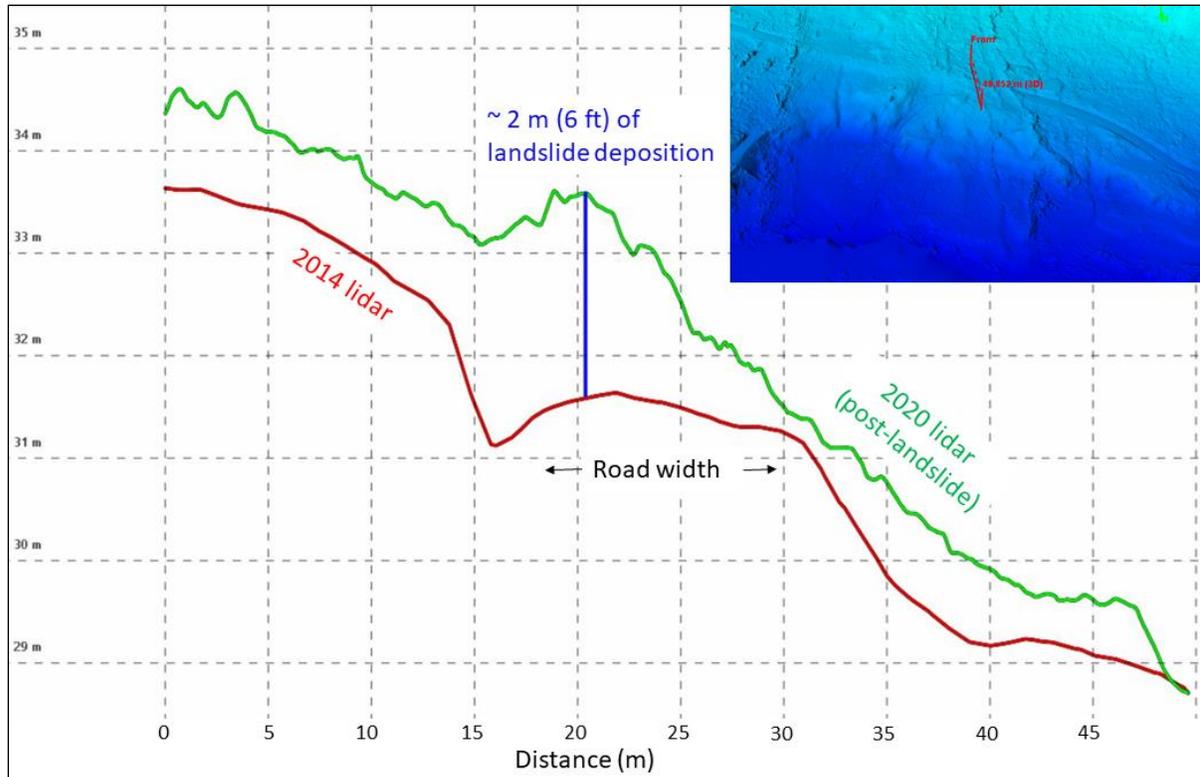
Figure 4. Cross section extending from above the road to below the road comparing land surfaces before and after the Beach Road landslide. Inset map shows location of cross section on 2020 lidar hillshade image.
